# Bioefficiency

## Material investigations for FB combustion systems (D3.1)

Authors:	Patrik Yrjas, Li Na
Version:	Final
Quality Review:	Person 2
Date:	26.02.2018
Partners involved:	Abo, Valmet

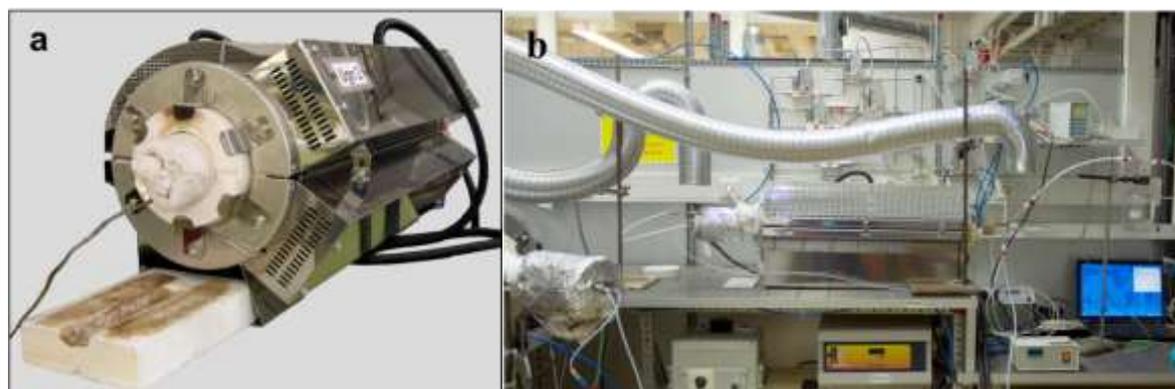
**Figure 1. Horizontal tube furnaces for corrosion tests a) ambient air and b) gas mixture + H<sub>2</sub>O (pictured by Linus Silvander).**

The exposures were carried out in a horizontal tube furnace for 168 h at 600 and 650 °C. One setup (Figure 1a) was made of a standard horizontal tube furnace in which the samples were exposed to ambient air while another setup included a pre-heater, water pump, and gas lines. The water was heated up to 200 °C and then introduced into the furnace together with the chosen gas mixture (Figure 1b). The gas atmosphere used in the tests composed of 6 % O<sub>2</sub>, 80 ppm SO<sub>2</sub>, 15 % H<sub>2</sub>O and balanced with N<sub>2</sub>.

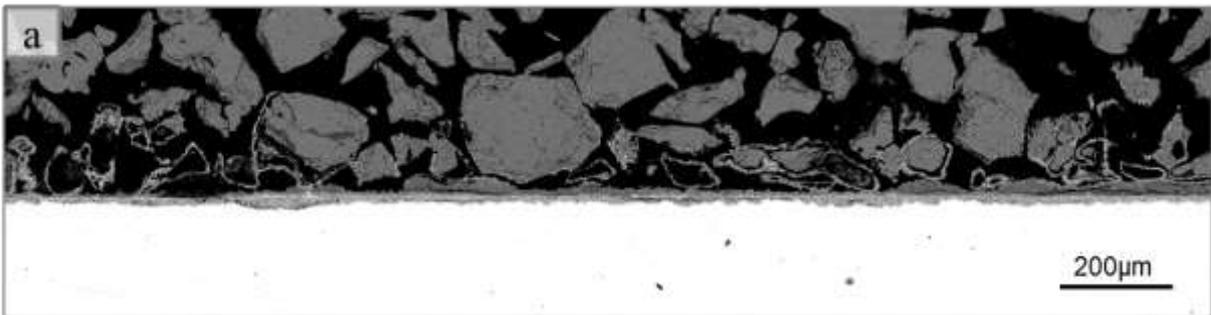
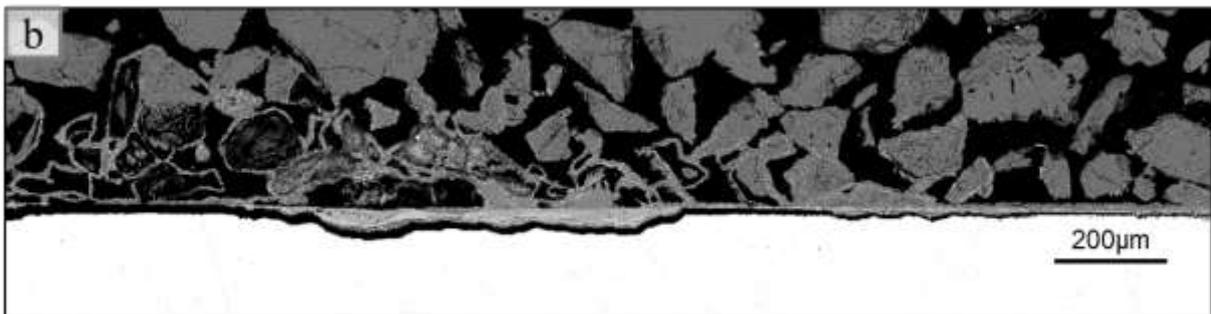
Figure 5. The panorama images of a) 304HCu and b) 304H after exposure to simulated flue gas with 5KCl-95K<sub>2</sub>SO<sub>4</sub> at 600 °C.
